Management Survey Asbestos Report

Ref: St Cleer Changing Facilities/M/130818

**St Cleer Sports Pavilion
St Cleer Football Ground
Liskeard
PL14 6EE**

Date report completed: 29th August 2018

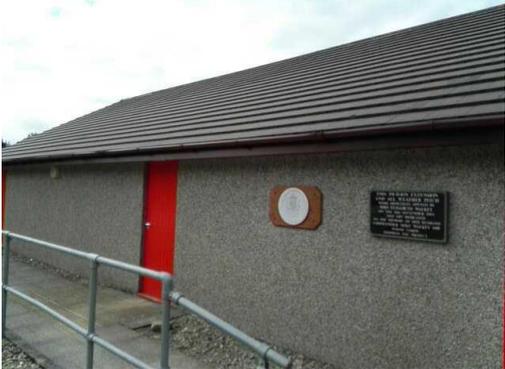
Internal, no asbestos. 2003 extension	Post 2001

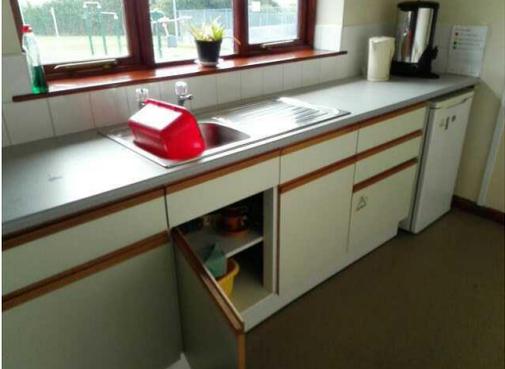
<p>Internal, no asbestos.</p>	<p>Area inspected in detail and no suspected asbestos containing materials identified.</p>

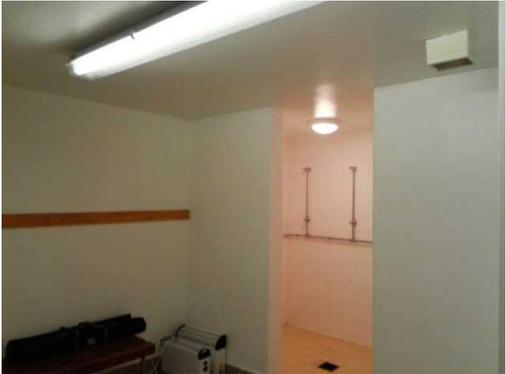
<p>Internal, no asbestos.</p>	<p>Area inspected in detail and no suspected asbestos containing materials identified.</p>

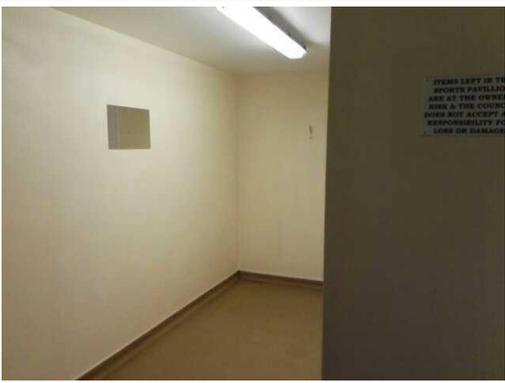
<p>Internal, no asbestos.</p>	<p>Area inspected in detail and no suspected asbestos containing materials identified.</p>

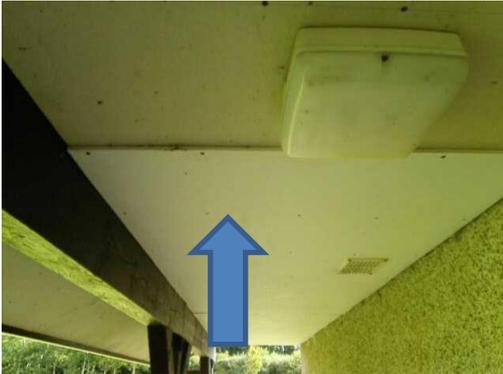
<p>Roofing, soffit boards, fibreboard panels.</p> <p><u>Sample 1 – Pitch-side porch</u></p>	<p>No asbestos detected in sample.</p>
