Management Survey Asbestos Report

Ref: St Cleer WC/M/130818

**33 Kilmar Way
St Cleer
Liskeard
PL14**

(Issue 2) Revised report completed: 11th December 2018

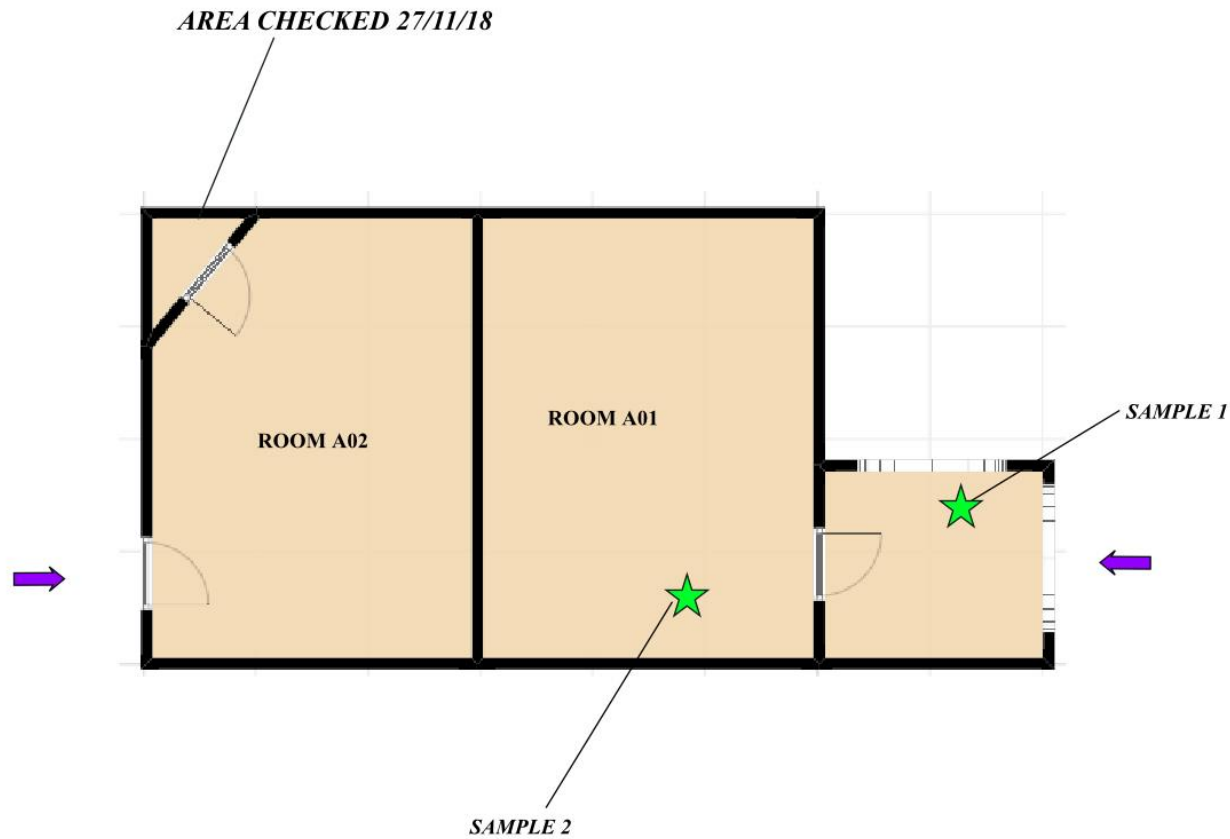
Appendix: Site Plans

Location/Item	Justification	Photo
Ceilings, ceiling, fibreboard panels. <u>Sample 2 – room 01</u>	No asbestos detected in sample	 
Roofing, soffit boards, fibreboard panels. <u>Sample 1 – external porch</u>	No asbestos detected in sample	 
Store cupboard	Previous Exclusion. Area checked 27/12/18. No asbestos
