St Cleer Parish Council

## Health, Safety and Security Report

Completed: 16/10/2026 15:46 Duration: 02h 52m 21s

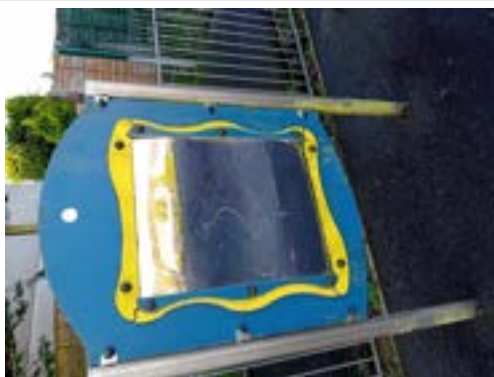
Image #25

The equipment is starting to build up green algae, I would advise arranging a thorough clean before the winter turns this into slippery surfaces especially on the high climbing frames.

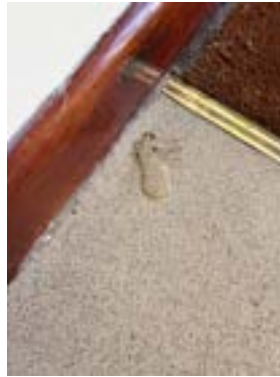
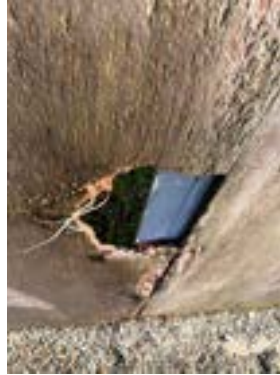
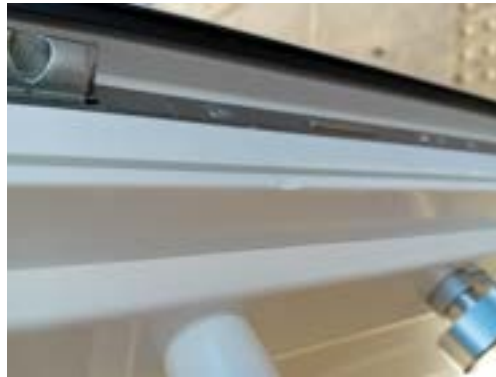
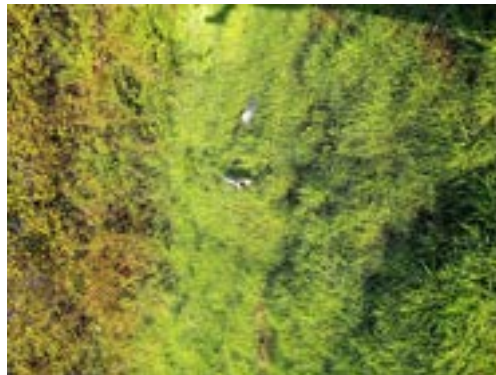
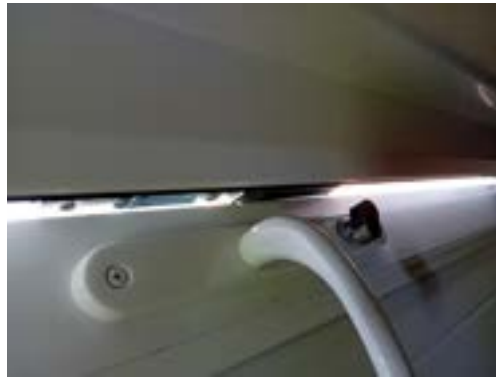
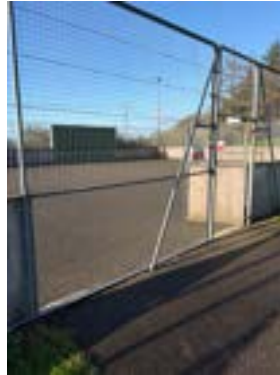
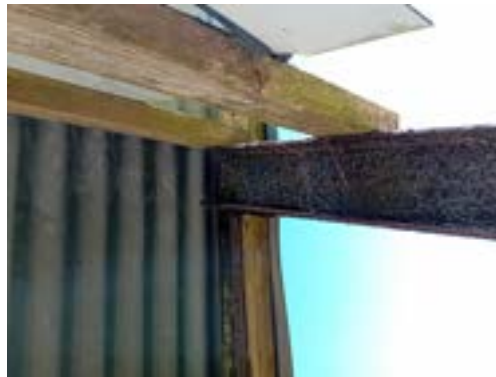
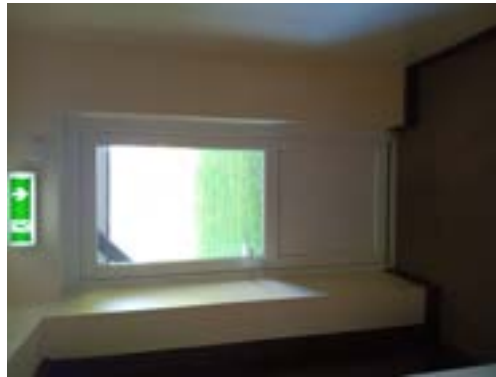
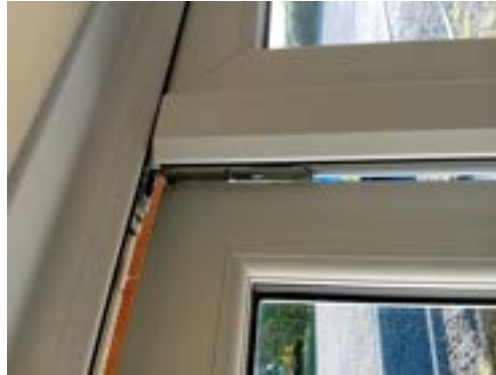
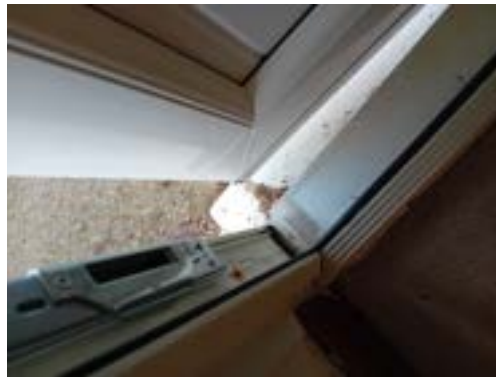
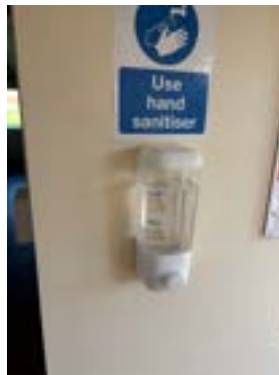
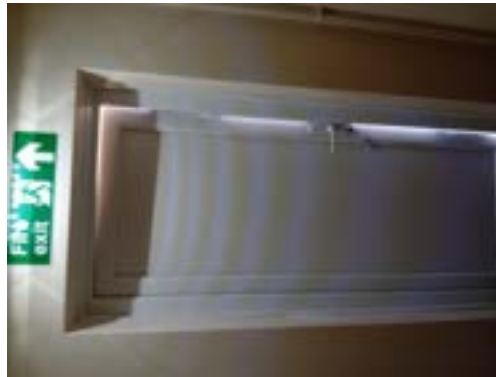
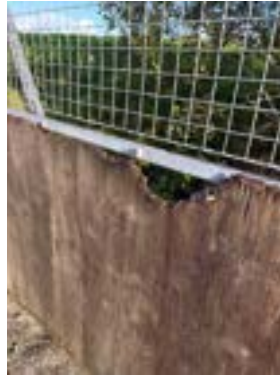
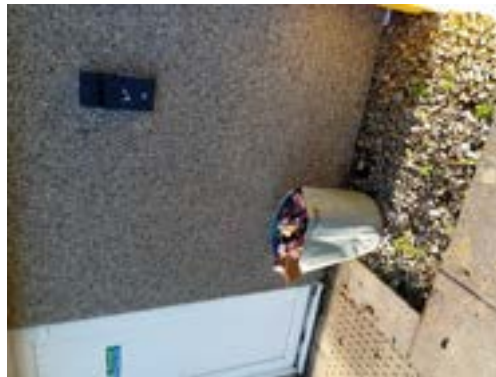
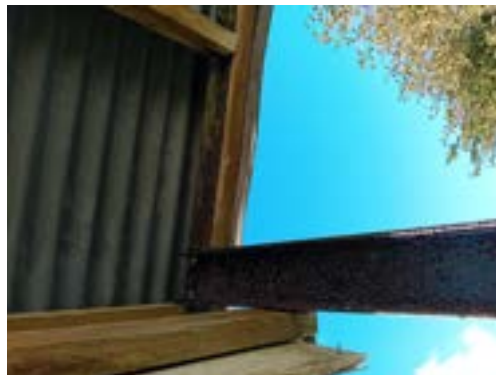
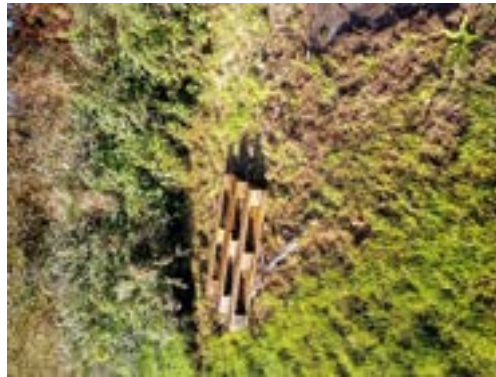
Following the maintenance concerns raised by email prior to the audit, the areas identified were inspected during the site visit. The observations and recommendations are as follows:

**Internal Doors** Several recently installed doors were found to be difficult to close and lock correctly. Based on visual inspection, the issue appears to be related to door alignment and/or hinge adjustment. As these doors have been recently installed, it is recommended that the installation contractor revisit and rectify the defects under their installation works. **Wet**

**Floor Hazard** The wet area observed on the floor was found to be caused by drips from the wall-mounted hand sanitiser dispenser located above. This presents a slip hazard to users of the facility. It is recommended that either: The hand sanitiser dispenser is relocated to a more suitable location; or A drip tray is installed beneath the dispenser to prevent liquid accumulating on the floor surface. **Referees' Room**

**– Lighting and Extract Fan** The lighting and extract fan within the referees' room were found to operate continuously and could not be switched off locally. The only means of isolation identified was via the consumer unit; however, this also isolates power to the junior corridor and changing room facilities. As the system is controlled by a PIR sensor, it is likely that the sensor or associated control equipment has malfunctioned. A suitably qualified electrician should be instructed to investigate and repair the fault. **Multi-Use Games Area (MUGA)** The MUGA was found to contain a number of missing and damaged perimeter boards. This is consistent with typical wear and tear associated with the facility. The damaged sections should be inspected to determine whether they present a risk of injury to users, and repairs

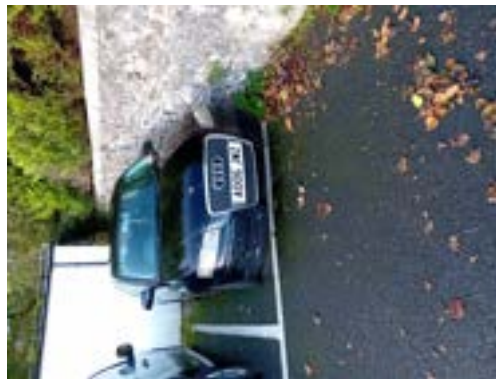
Image #3

**There is still a parked vehicle in the carpark which is SORN. A Black Audi Reg AO 06 JWZ. this is an ongoing issue which would require a legal team or Cornwall County Council to implement a compliant clamping or penalty notice zone in the carpark. The outdoor gym equipment is beginning to show signs of aging with rust at connection points. This should be monitored and prevent from further deterioration.**
