Management Survey Asbestos Report

Ref: St Cleer Changing Facilities/M/130818

**St Cleer Sports Pavilion
St Cleer Football Ground
Liskeard
PL14 6EE**

Date report completed: 29th August 2018

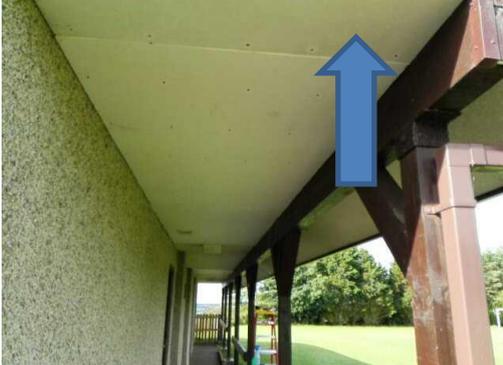
<p>Roofing, soffit boards, fibreboard panels.</p> <p><u>Sample 1 – Pitch-side porch</u></p>	<p>No asbestos detected in sample.</p>
