St Cleer Parish Council

## Health, Safety and Security Report

Completed: 16/10/2026 15:46 Duration: 02h 52m 21s

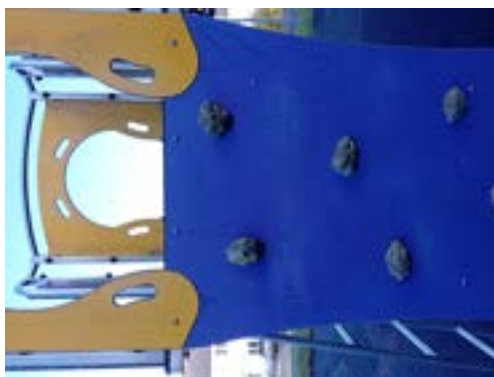
Image #23

The equipment is starting to build up green algae, I would advise arranging a thorough clean before the winter turns this into slippery surfaces especially on the high climbing frames.
